Fairview Former Post Office

Building Inventory Form

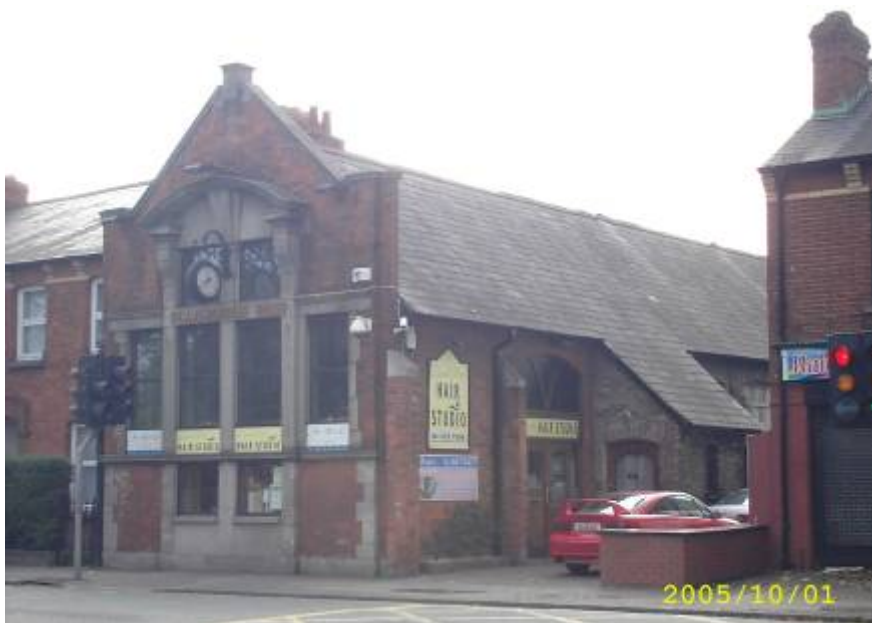
Figure 7/31 – Fairview Former P.O., c.1889; Photo, Author, 2005

This former post office building is located on the south side of Fairview Strand opposite the junction of Philipsborough Avenue, Figure 7/30 and 7/31. It is a detached building located between a row of terraced two storey brick houses to the east side and two semi-detached two-storey shop units, of a later period, to the west side.

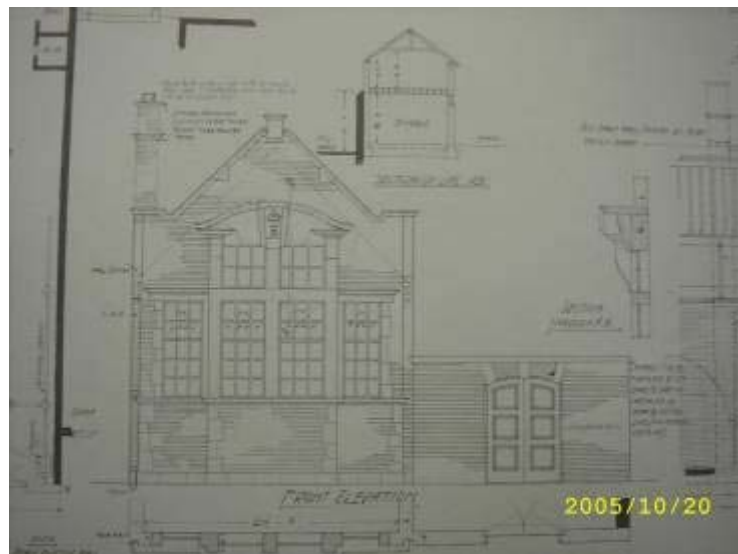
Figure 7/33 – Fairview P.O., c. 1889; Original Front Elevation Drawing²⁹⁷

The front façade differs from the original elevation drawing as the brickwork below the front windows is now stone, Figure 7/33.
