Fairview Former Post Office

Building Inventory Form

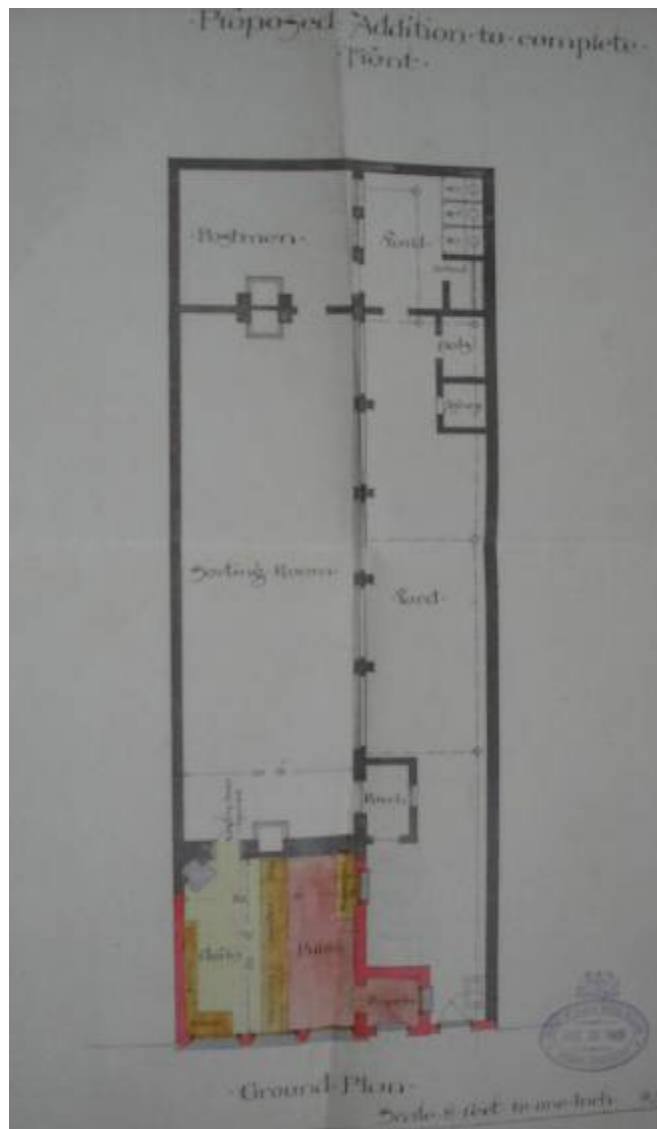
Figure 7/32 – Fairview Former P.O., c. 1889; Ground Floor Plan with additions²⁹⁶

Single storey four bay gable fronted brick and stone post office building built 1901. This building was built in two phases and is described in detail in Chapter 5. The first phase consisted of a Sorting Office with Entrance Porch and a Postmen's Room at the rear of the building. The external Yard consisted of a Coals store, an Ashes store, a Urinal area and three W.C.s, all shown uncoloured in Figure 7/32. The second phase consisted of the addition of a Public Office, with Entrance Porch and a Clerks area. This construction brought the building line of the postal office out to the street and the works shown coloured in Figure 7/32 indicate this.

The original footprint survives but the internal layout to the former public office is much changed. Access was not permitted to the remaining areas.
